How Heat Treatment Can Contribute to Fastener Failures & Methods of Prevention

The following is a case study revealing heat treating as the root cause of fastener failure.

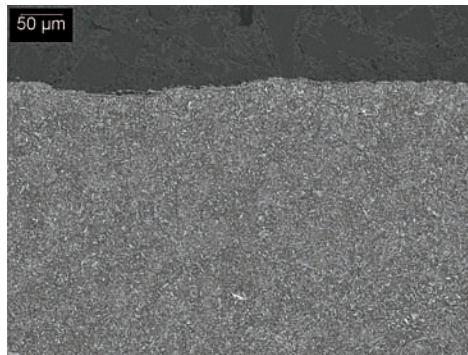
A cross sectional examination was performed on both the good and bad fasteners as well. Both of the samples revealed a tempered martensite microstructure. A continuous film that is approximately 100 microns thick was observed on the exposed surfaces and fracture cross sections of bad fastener. In contrast, the surface film on the good fastener was approximately 2 microns thick.

Surface microstructure of good sample revealing thin oxide film at the surface.

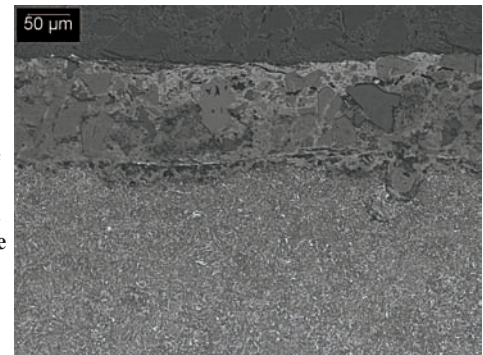
- The good fasteners were properly heat-treated exhibiting a surface and core microstructure of tempered martensite. A thin oxide layer was observed on the part surface indicative of tempering at elevated temperature in air.
- The bad fasteners were cracked during the heat treatment process, either the result of thermal or quenching stresses. The same composition and thickness of oxide layer was observed on the fracture surface as well as the outside diameter of the part.
- Hardness values (converted from microhardness measurements) on the bad fasteners found they were out of specification (high) indicating an inconsistency in response after the re-hardening operation. These measurements are considered more accurate than attempting to hardness test the surface using conventional Rockwell "C" measurements with scale present.

Surface microstructure of bad sample revealing thick oxide film at the surface.

In this instance, corrective action consisted of instructions to the commercial heat treater not to re-work the parts, but to quarantine them until a thorough metallurgical analysis could be performed on them.

Further it was suggested that parts should be tested using dye penetrant or similar methods for the presence of cracks after heat treatment.

Additionally, routine (per batch) quality checks should be performed utilizing an independent source.

Finally, in-house heat treating should be considered if the problem is found to persist or if the quality control measures suggested above cannot be implemented.

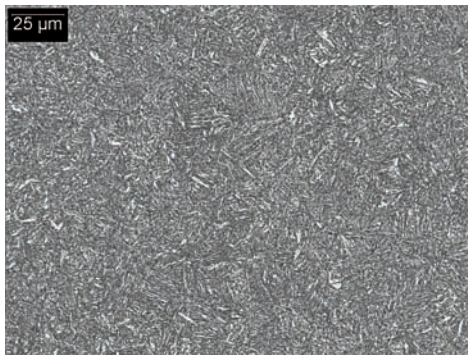
Core microstructure of good sample consisting of tempered martensite.

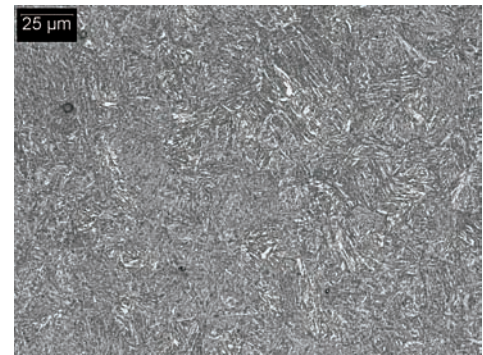
Core microstructure of bad sample consisting of tempered martensite.

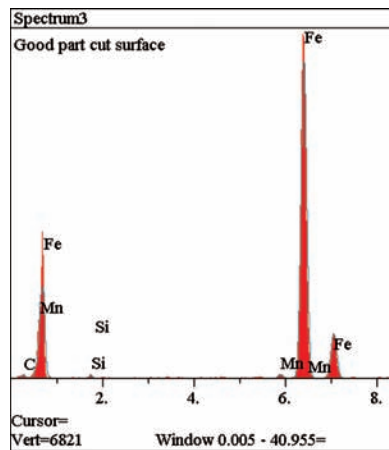
Both the OD surface of the good fastener and the baseline material were analyzed by SEM/EDX for comparison with the bad part. The analysis revealed less oxidation on the good fastener OD surface. The material was identified as *SAE 1045* steel based on analysis of the sectioned part wall.

Baseline EDX results.

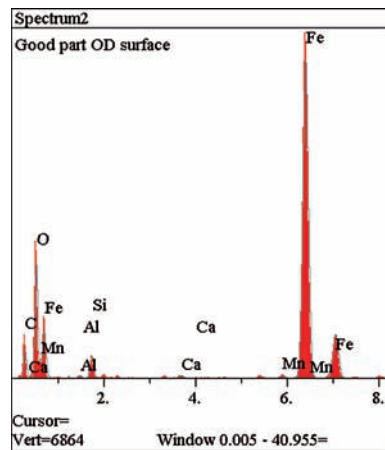
EDX results on OD surface of good sample.

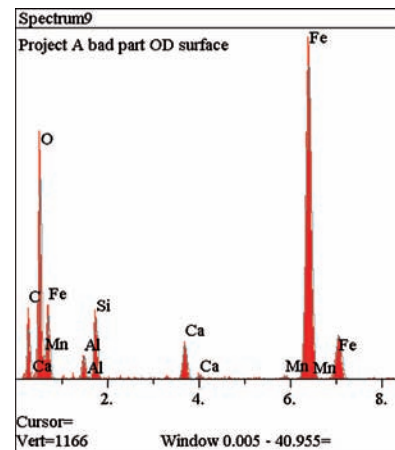
The fracture surface of the bad fastener appeared uniformly black—the same color as the exposed surfaces on the bad part. SEM/EDX analysis was performed on both the fracture surface and the exposed OD surface for comparison. Both of the analyzed bad fastener surfaces revealed continuous coverage with the oxide film with identical elemental composition.

EDX results on OD surface of bad sample.

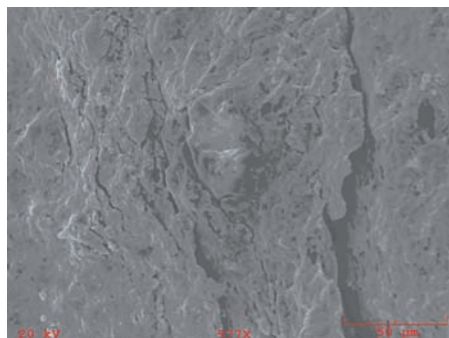
SEM view of surface of good sample.

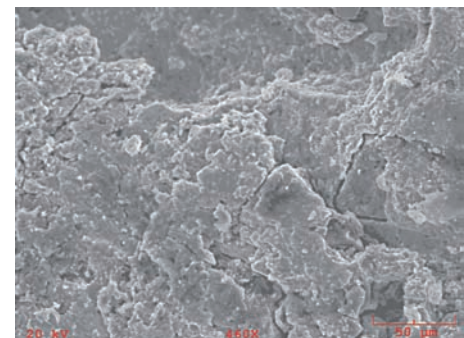
SEM view of surface of bad sample.
